University of Alberta.

Master of Science

# Fatigue Failure of Total Hip Prostheses

The problem of fatigue failure of total hip prostheses implanted in the human body is investigated. An experimental model is developed to simulate in vivo loading and various femoral components of total hip prostheses are tested in order to determine their projected life.

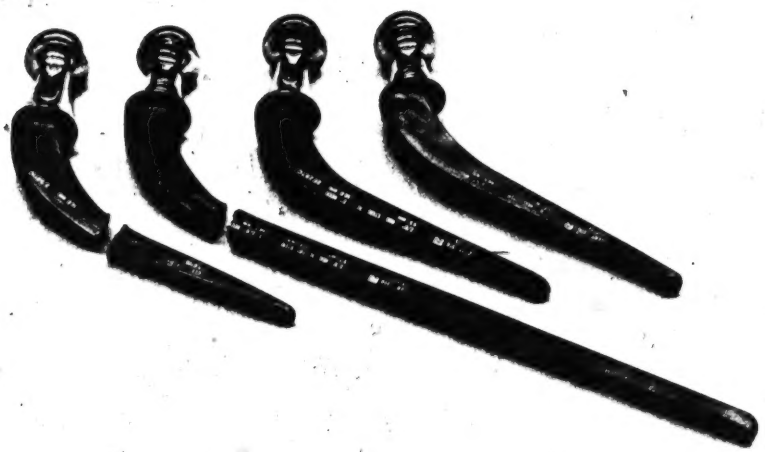
Plate 2

A significant number of the total hip replacement stems have fractured after being in use several months or longer. Recently new metals have been developed for use in the stem. No study exists that adequately assesses the design and materials currently used in total hip replacements.

prostheses, in order to assist the orthopaedic surgeons at the University of Alberta Hospital in their selection of a particular brand of prosthesis. The most important parameters required for the evaluation of each type of stem are the maximum expected stress, the material endurance limit, and the material fracture toughness. A knowledge of these properties will aid in the selection of a prosthesis type with the objective of reducing the probability of stem failures such as those shown in Plates 2-5.

Broken Stems

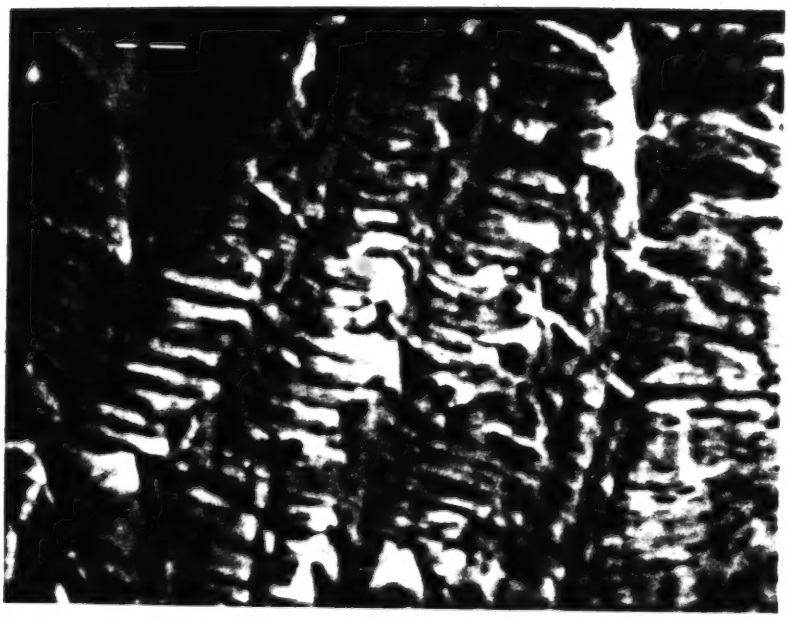
Plate 5

Fatigue Striations (5000X)

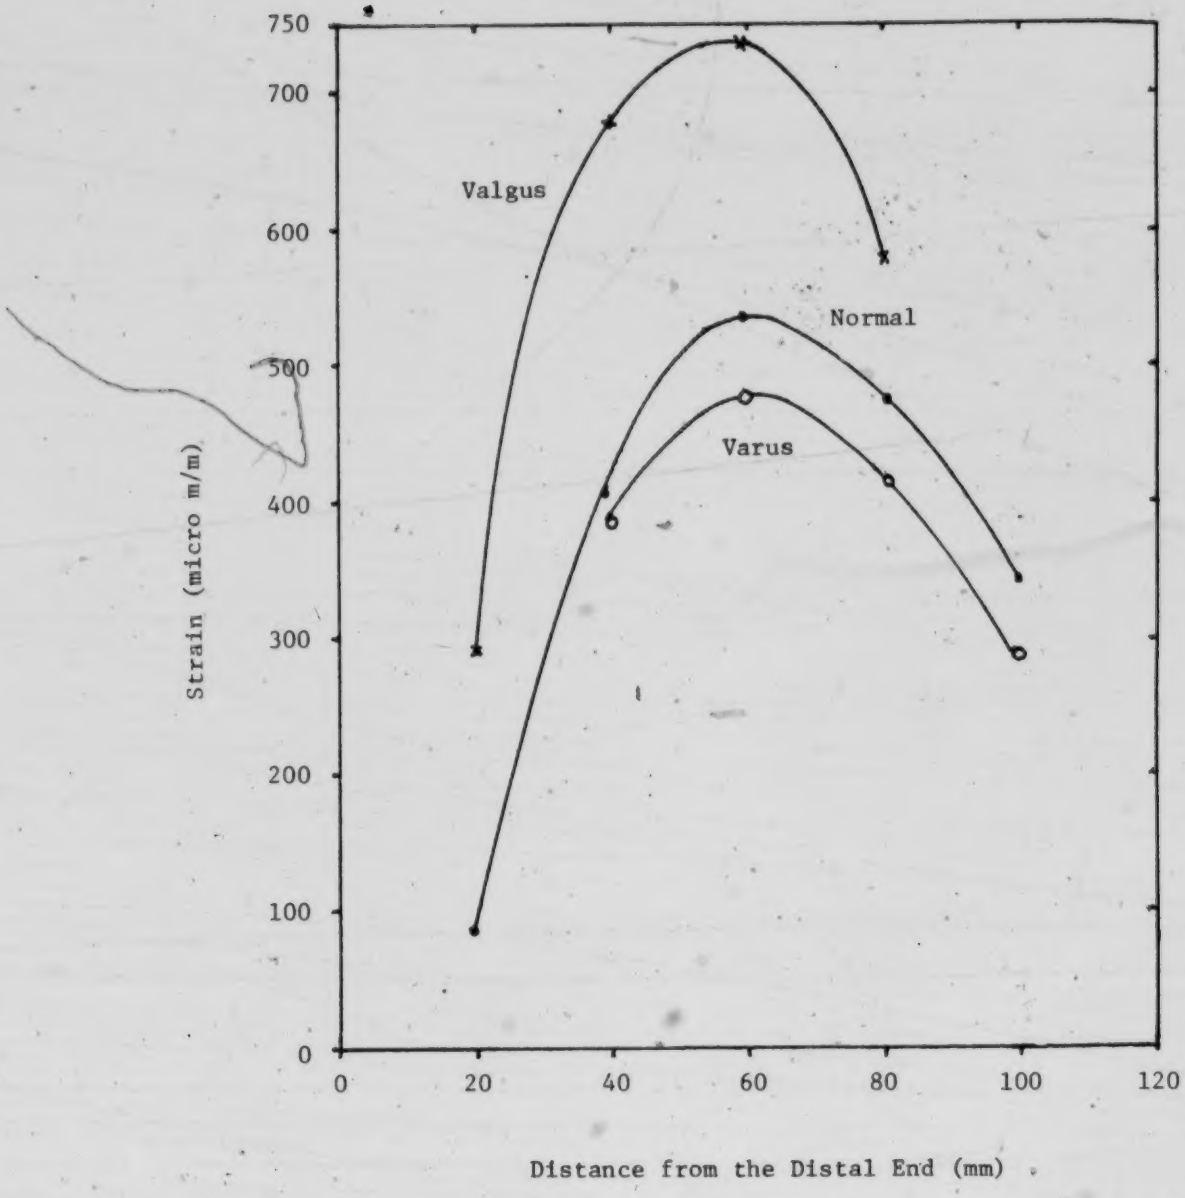
**Figure 30**

Figure 30 displays the effects of varying the position of the distal end of stem #23 from the medial side of the tube to the lateral side of the tube, or from the varus to the valgus position. It can be seen that the maximum stress is increased by placing the stem in a valgus position, and decreased by placing the stem in a varus position.

**Lateral Face Strains Measured on Stem #23 in Three Positions**

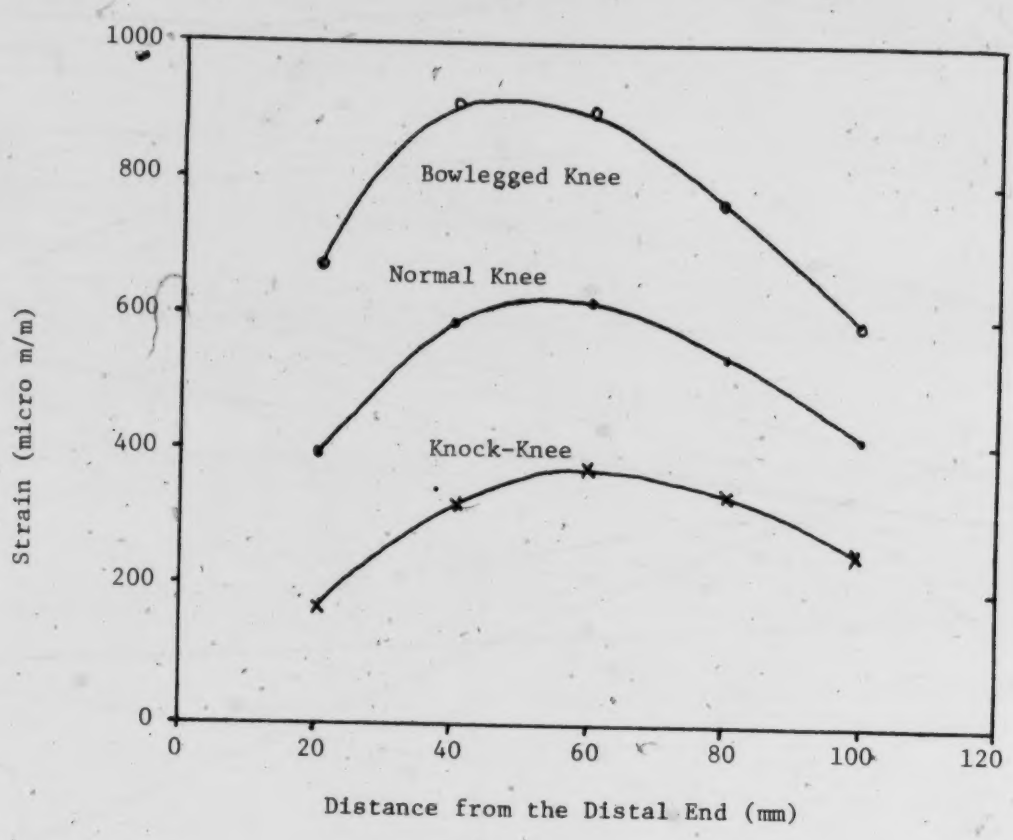
Figure 31

The change in stem strain due to altering the knee position varied depending on which stem was used. The increase in the maximum strain due to a bowlegged knee position ranged from 29% to 58%. The decrease in the maximum strain due to a knock-knee position ranged from 25% to 54%. This change is illustrated in Figure 31.

Lateral Face Strains Measured on
Stem #18 in Various Knee Positions

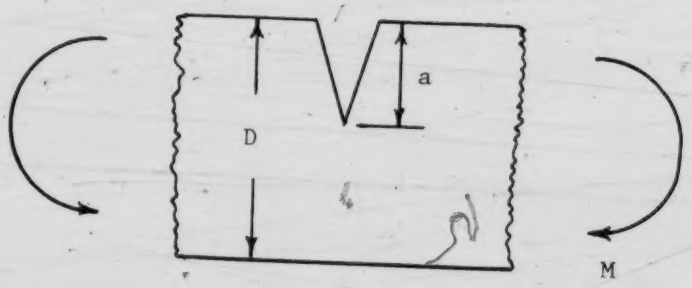
Figure 35

If the crack is assumed to traverse the stem, as in Figure 35, the stem becomes an edge-cracked bend specimen. Wilson [14], using a boundary collocation method, has derived an expression which he proposes may be used to determine a more accurate stress intensity factor for this type of specimen:

Where 'M' is the moment per unit width, 'D' is the specimen depth, and 'a' the crack depth. The critical flaw size can be determined by substituting $K1_c$ for K1 and using the maximum possible moment for 'M'. The assumption of a transverse crack, across the stem width, is an exaggerated representation of the case that might be encountered in total hip prostheses.

Edge-Cracked Bend Specimen
